HO-49

Mount Hebron (Mt. Hebron)

Architectural Survey File

Mt. Hebron

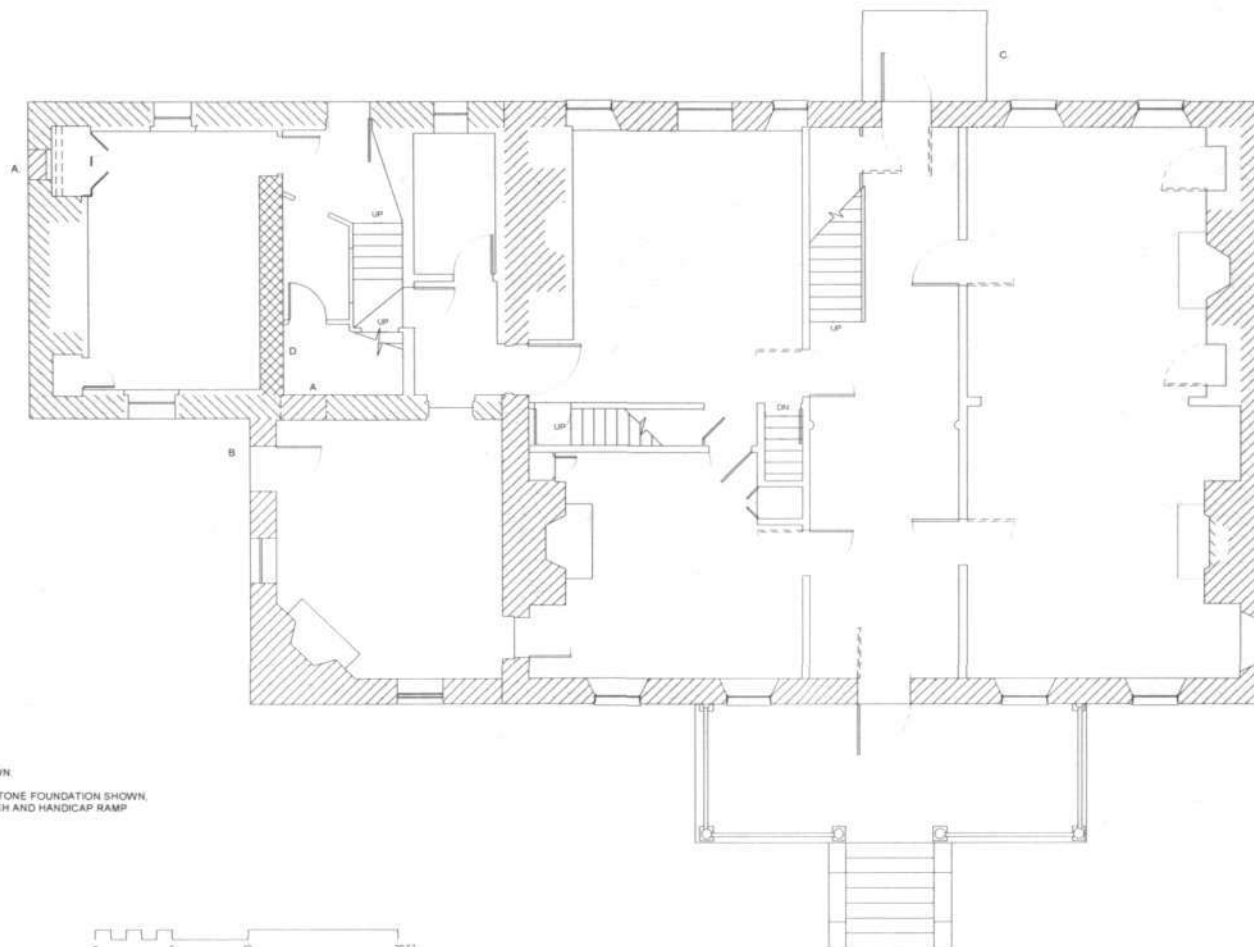
HO-49 MT. HEBRON MANSION CALVIN CIRCLE

FIRST FLOOR PLAN - MEASURED BY KEN SHORT AND LAURA DORSEY - DRAWN BY KEN SHORT - APRIL 2006

NOTES:

- A. MANTEL
- B. NEW CMU PORCH NOT SHOWN
- C. APPROXIMATE LINE OF ORIGINAL PORCH - NO LONGER STANDING
- D. PARTIAL FOUNDATION FOR ADDITION - NO LONGER STANDING

The mansion house is a two-and-one-half story, five-bay by two-bay rubble stone structure with quoins at the corners. It faces south and has a gable roof with asphalt shingles and an east-west ridge. There is a two-story, one-bay by two-bay rubble stone addition on the southwest that has a shed roof that slopes down to the north. There is also a two-story, four-bay by one-bay rubble stone addition on the northwest that also has a shed roof that slopes down to the north. The front of the house is landscaped with a semi-circular arch of ground that drops off beyond it, and with some large mature trees and several smaller ones planted along this arc. The mansion house has a center-passage, double-pile plan with an addition on the west.

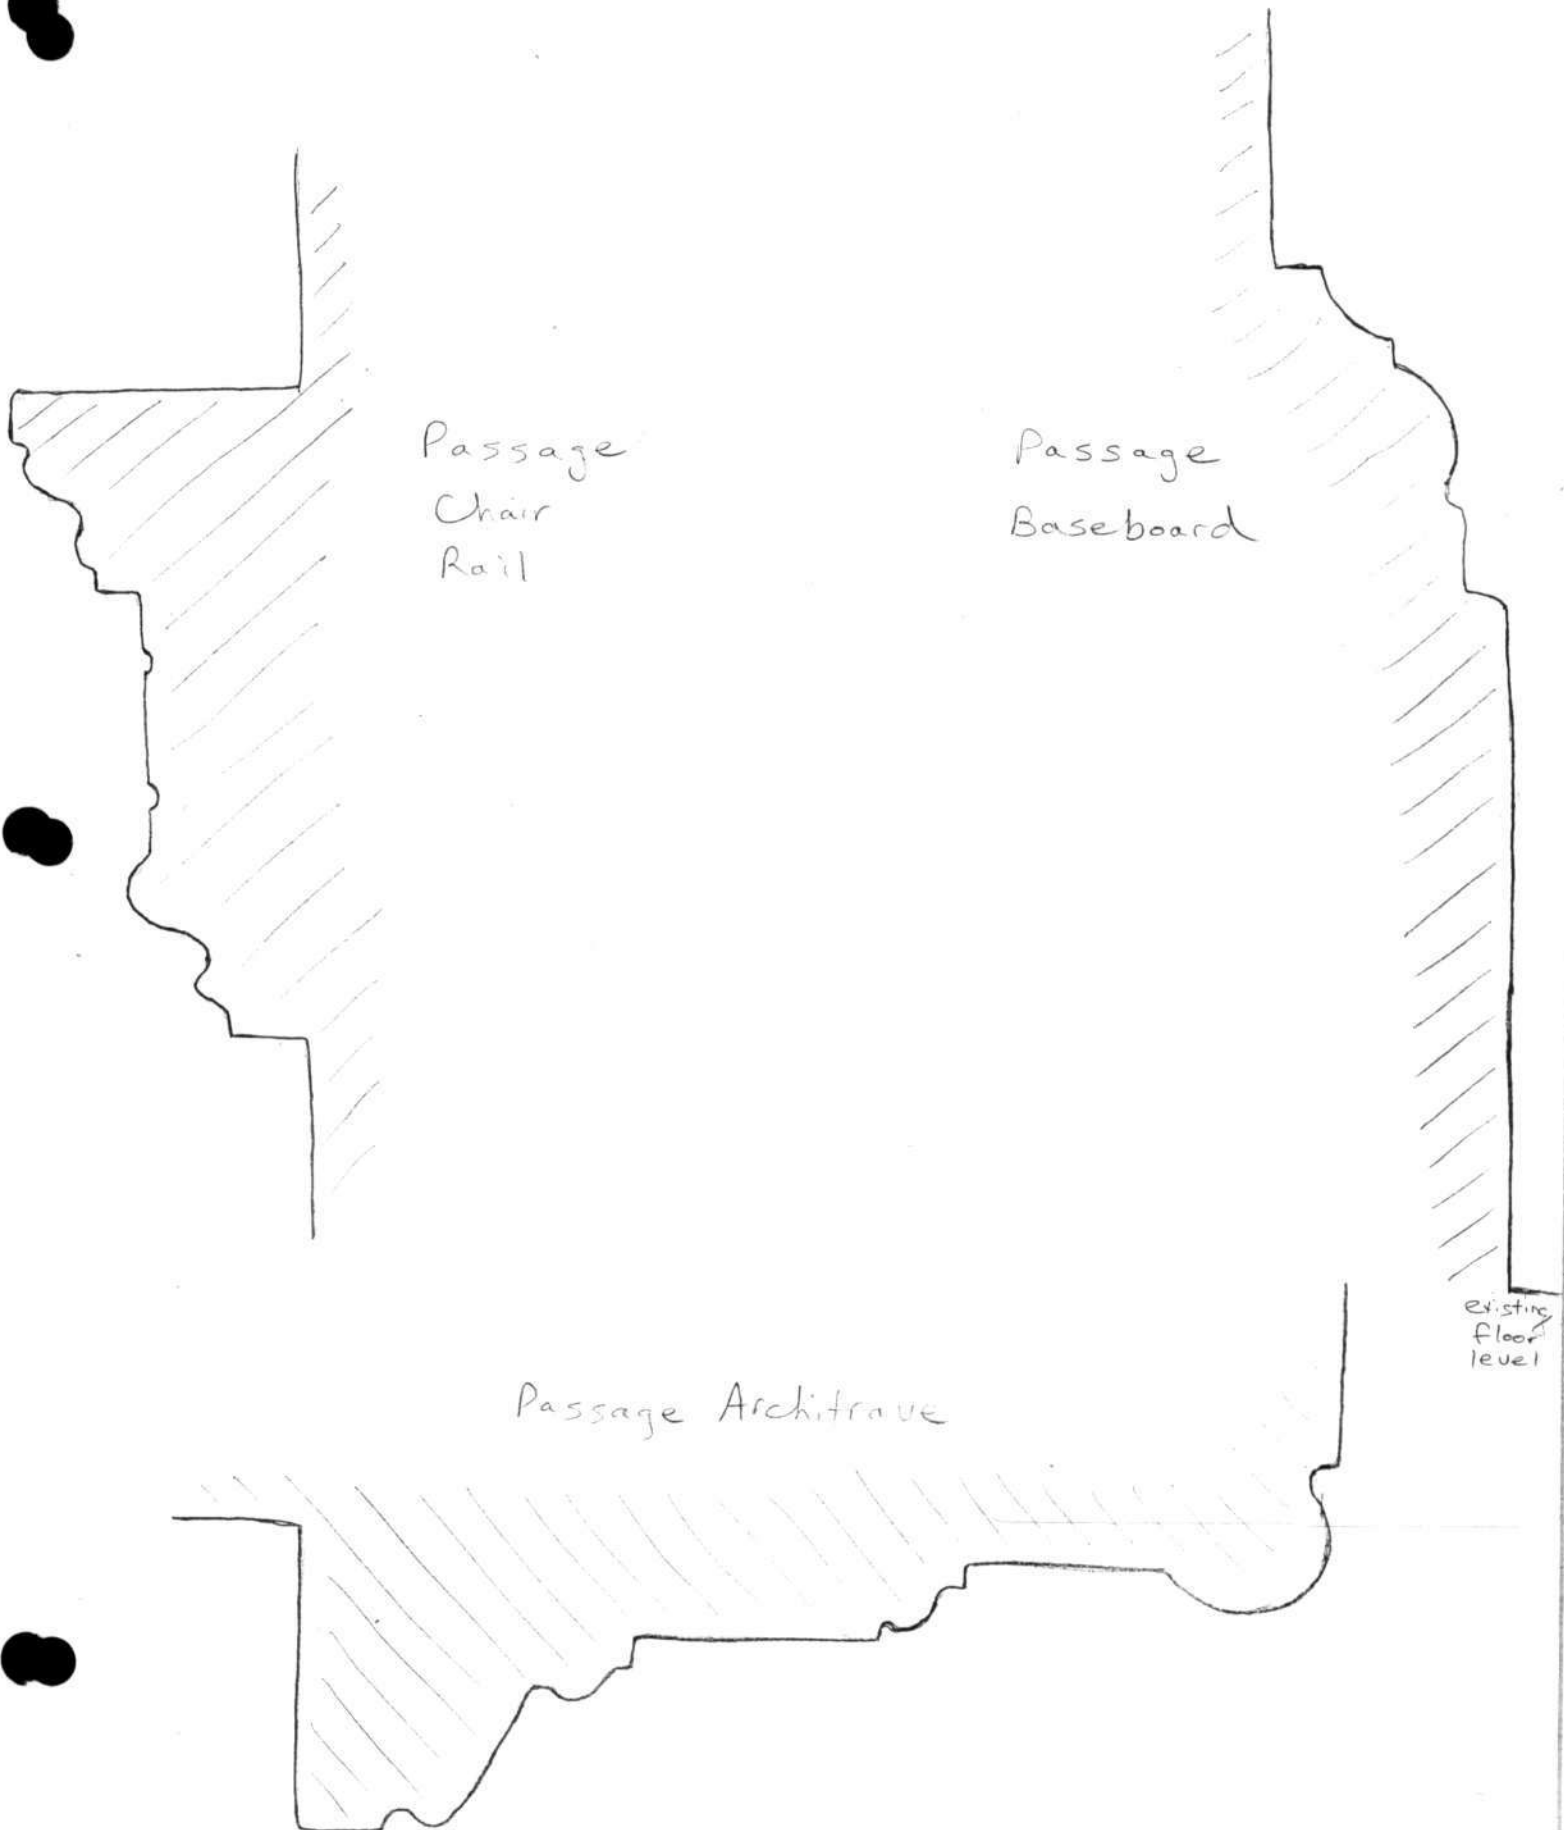
2/10

Mt. Hebron HO-49
Passage Column

them if he wanted. But the plan of his house is a traditional center-passage double pile, with no unusually-shaped rooms. The division of the passage through the use of engaged half-columns and an archway is a refined feature, but hardly a new one. Nor are the finishes as elaborate as the best country houses around Baltimore, such as "Bolton," "Homewood," "Montebello," "Willowbrook," or "Druid Hill." The mansion was grand, but not cutting-edge, and the use of stone helped to convey this. Beyond its use for foundations, stone construction was never common; in central Maryland, less than five percent of houses were of stone in the eighteenth and nineteenth centuries, though in the Ellicott City area, where there have been several quarries, it may have been a little more common. The use of stone in farm buildings was even less common than it was for dwellings. Its use at Mt. Hebron reflects both its availability (there were quarries on the property) and the great wealth of Judge Dorsey (who owned over 2,100 acres).

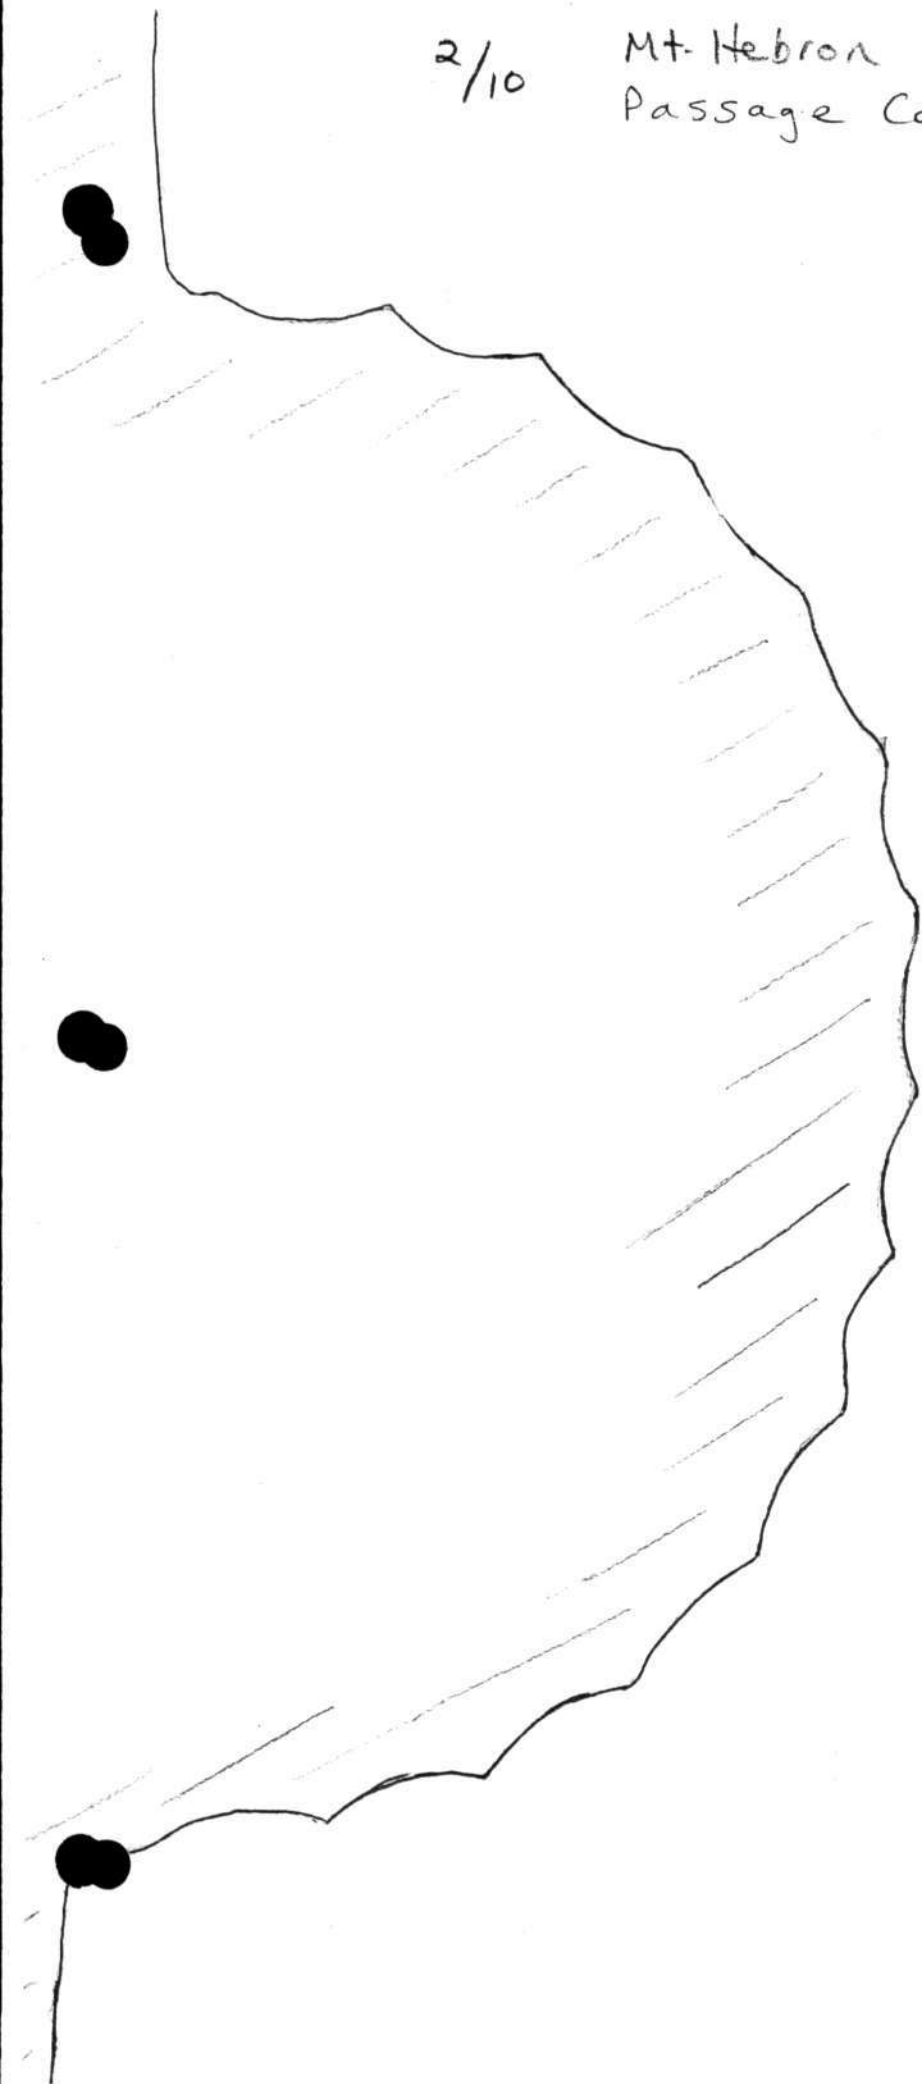
3/10

Mt. Hebron HO-49
Passage Ceiling Cornice

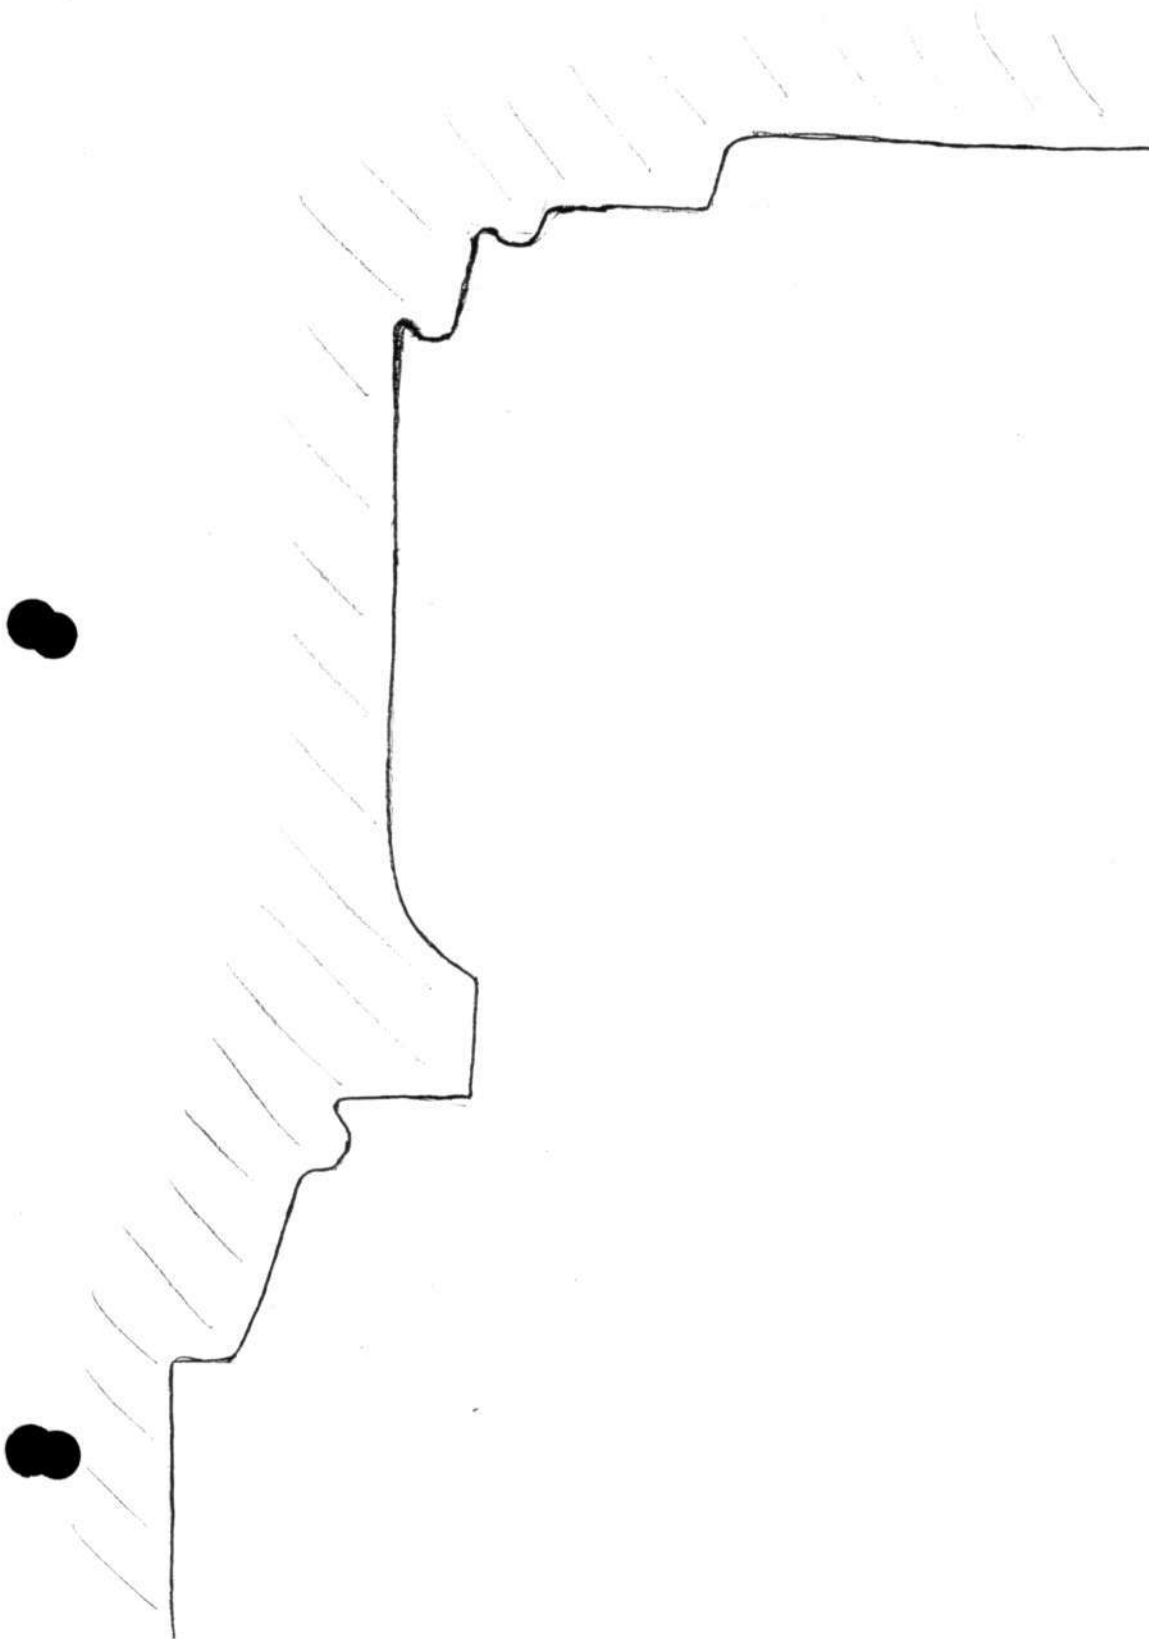
4/10 Mt. Hebron HO-49
Stair bracket

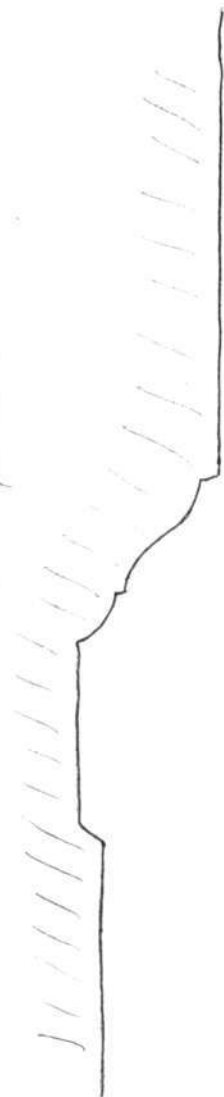
SW. Rm W. Door
Architrave

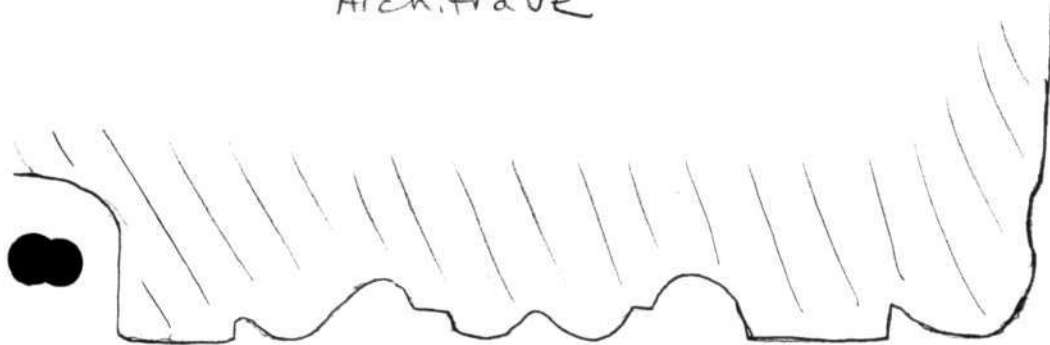
SE Room
Window
Architrave
& jamb

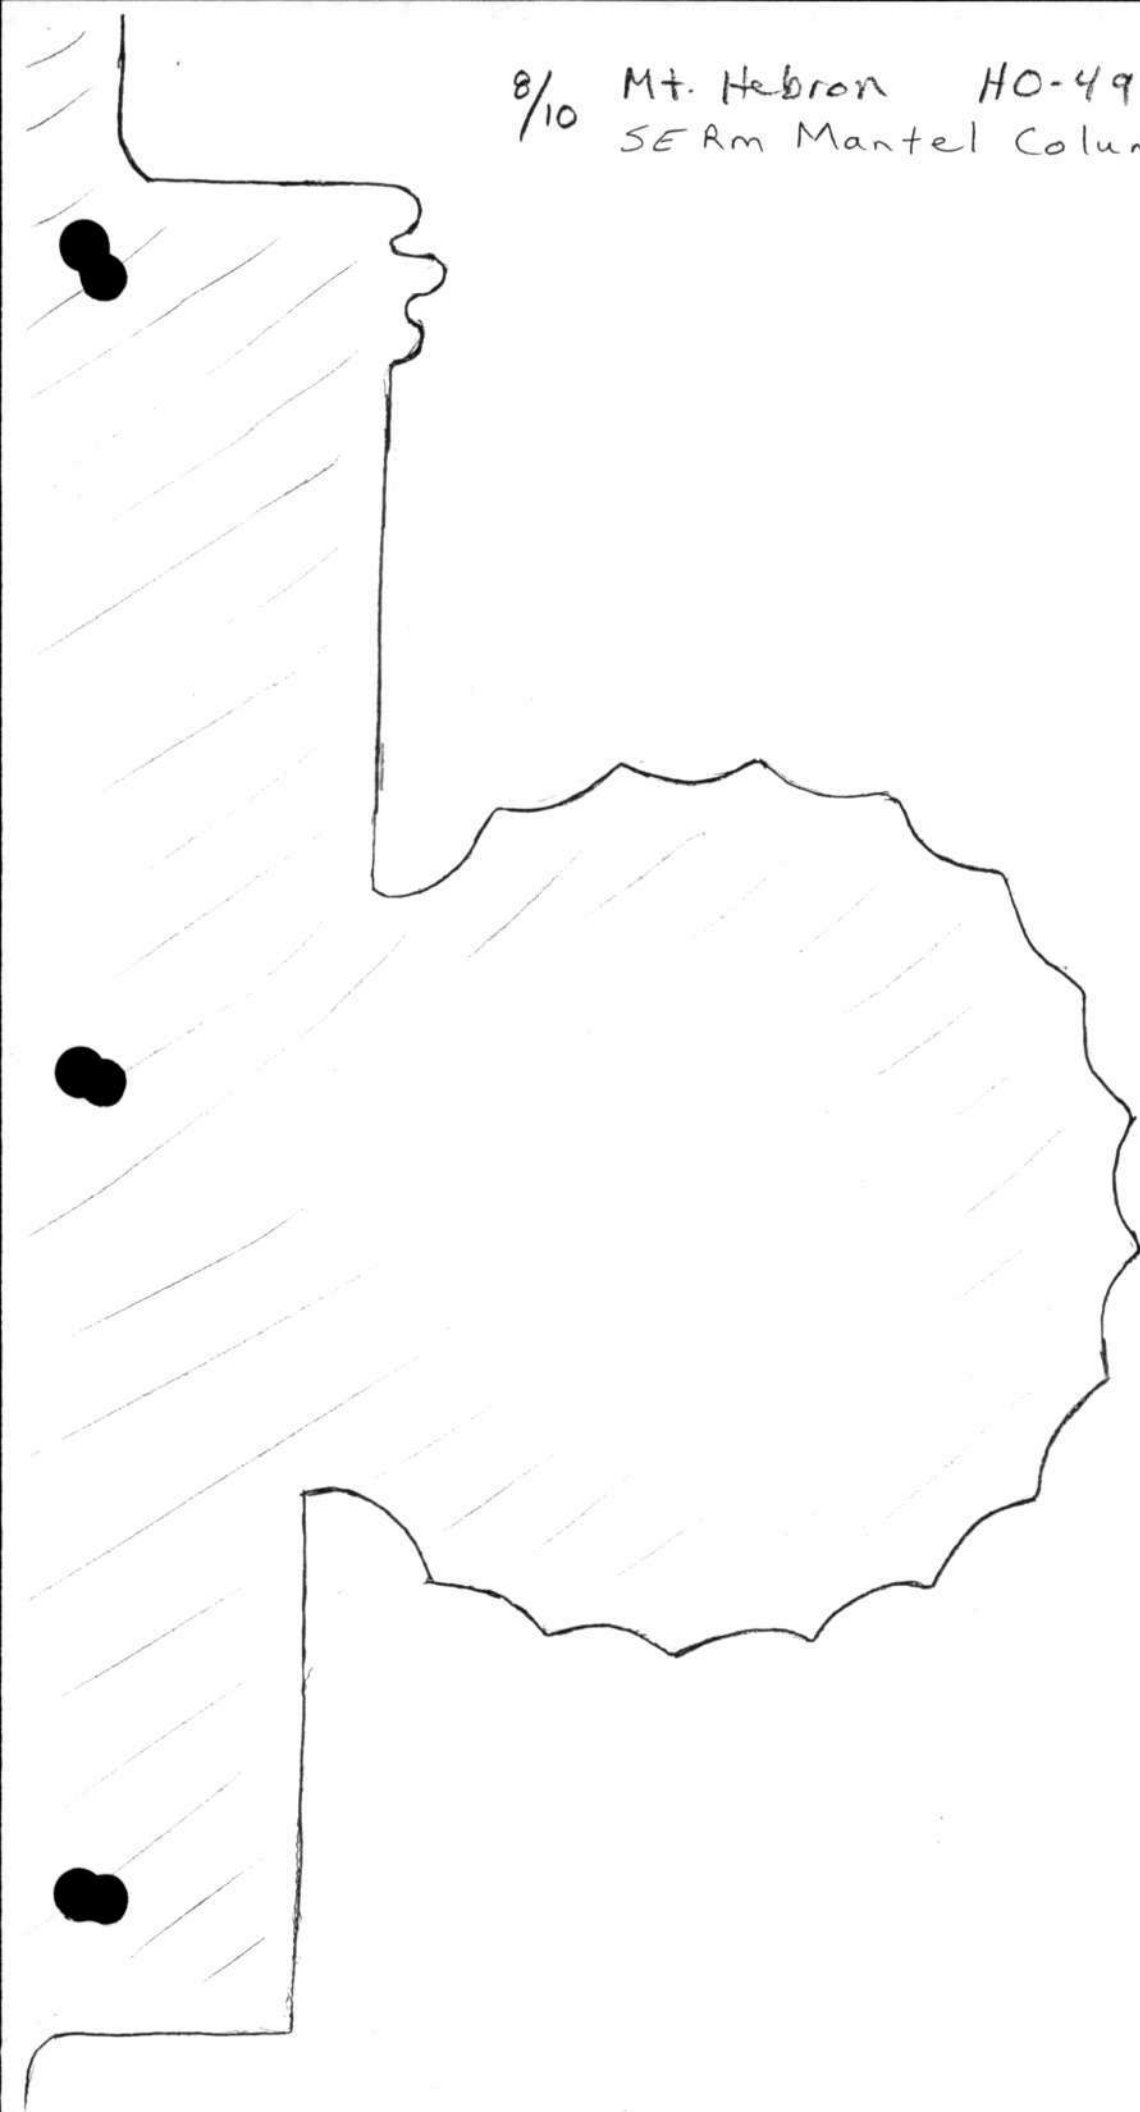
8/10 Mt. Hebron HO-49
SE Arm Mantel Column

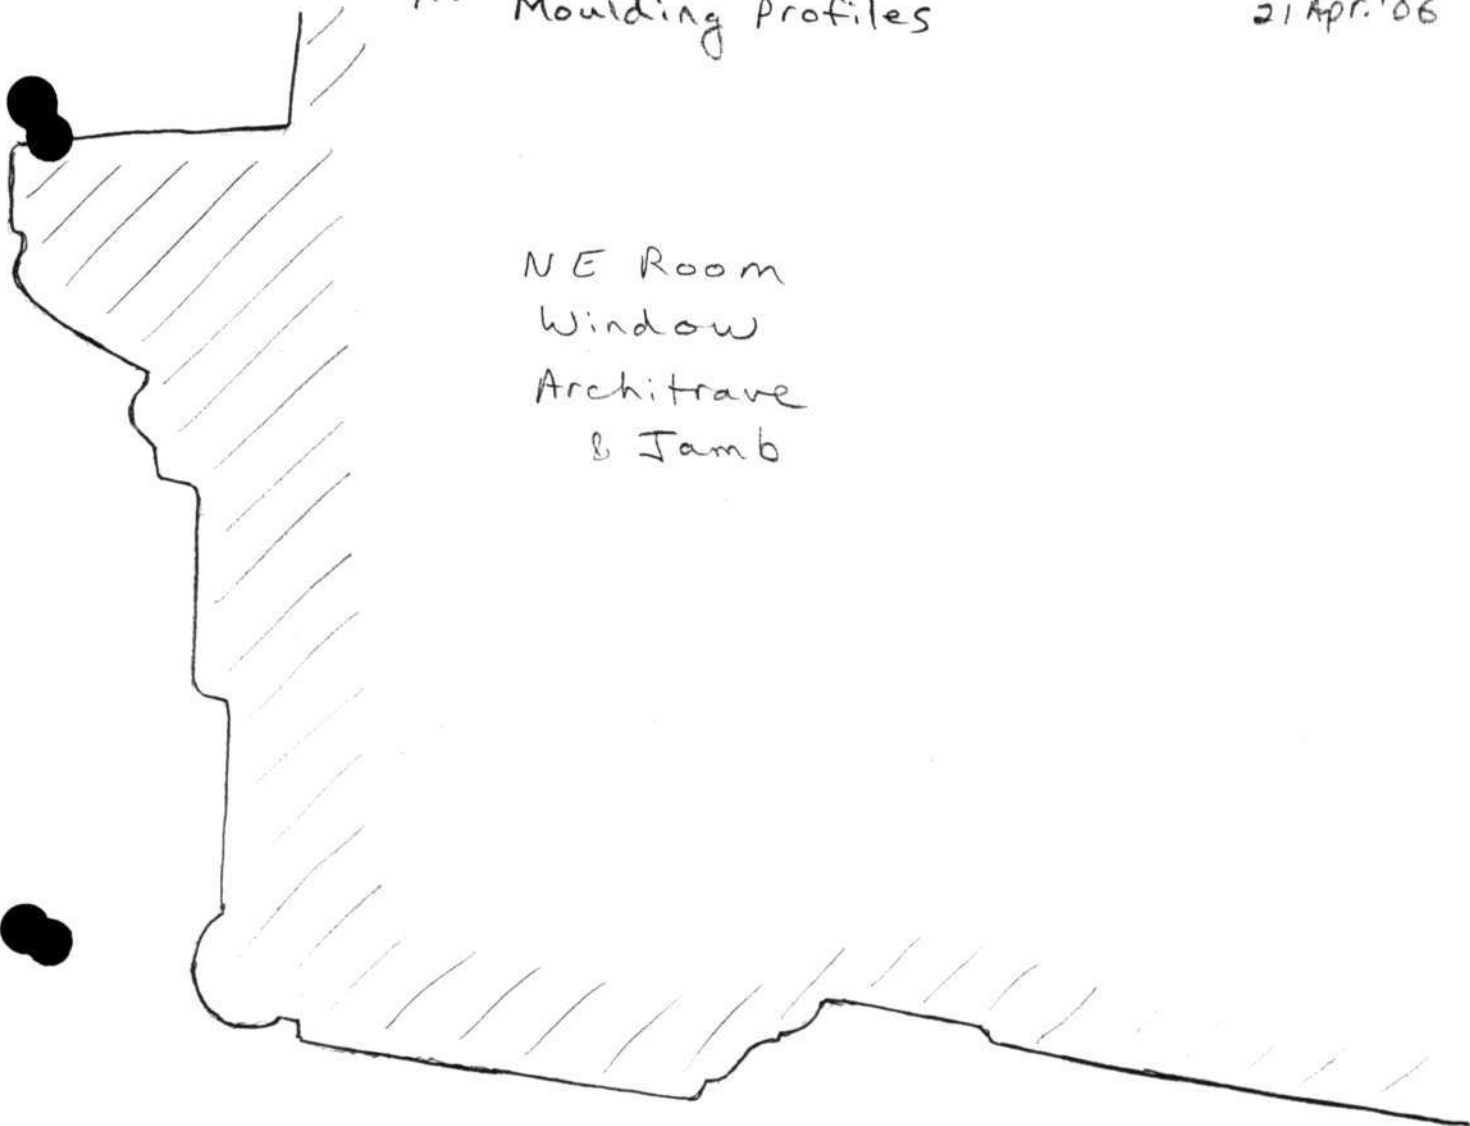
NE Room
Window
Architrave
& Jamb

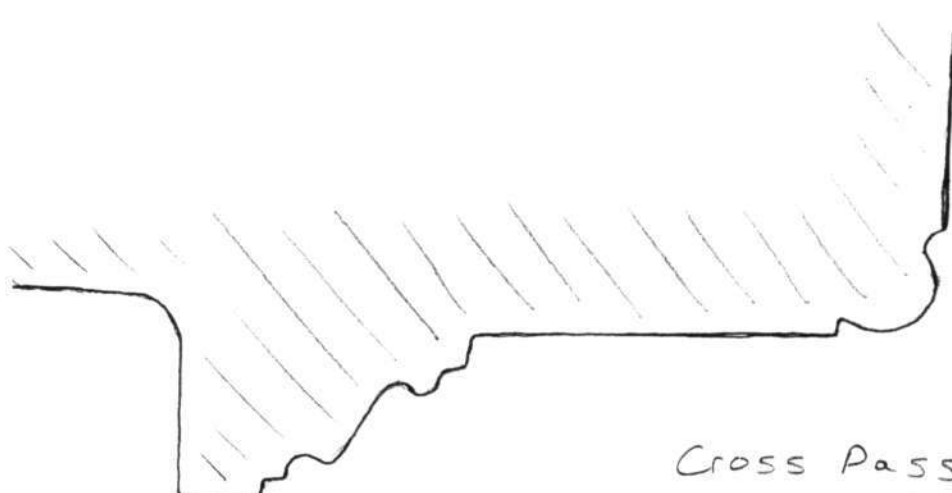
Cross Passage
SW chamber
Door Architrave

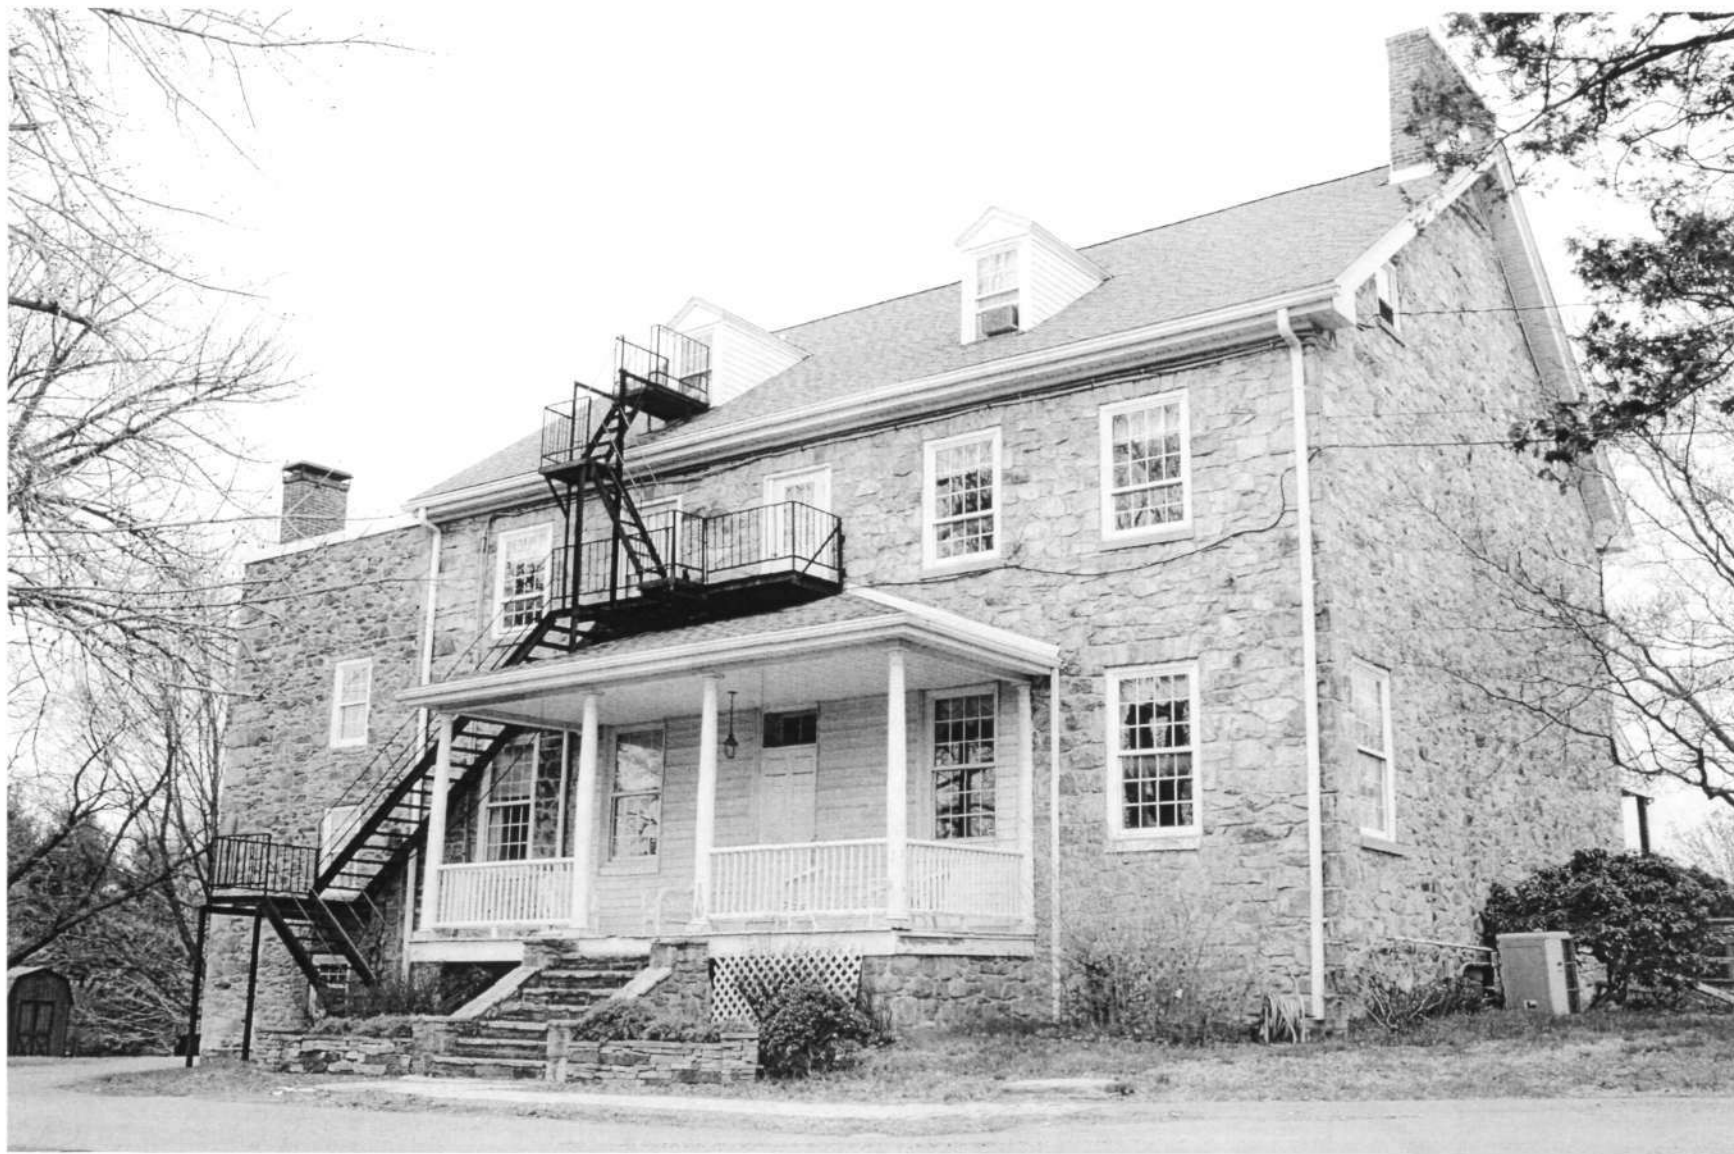
HO- 49 Mount Hebron, Calvin Circle & Furrow Avenue Mansion House, south & east elevations
Ken Short, April 2006, 1/30

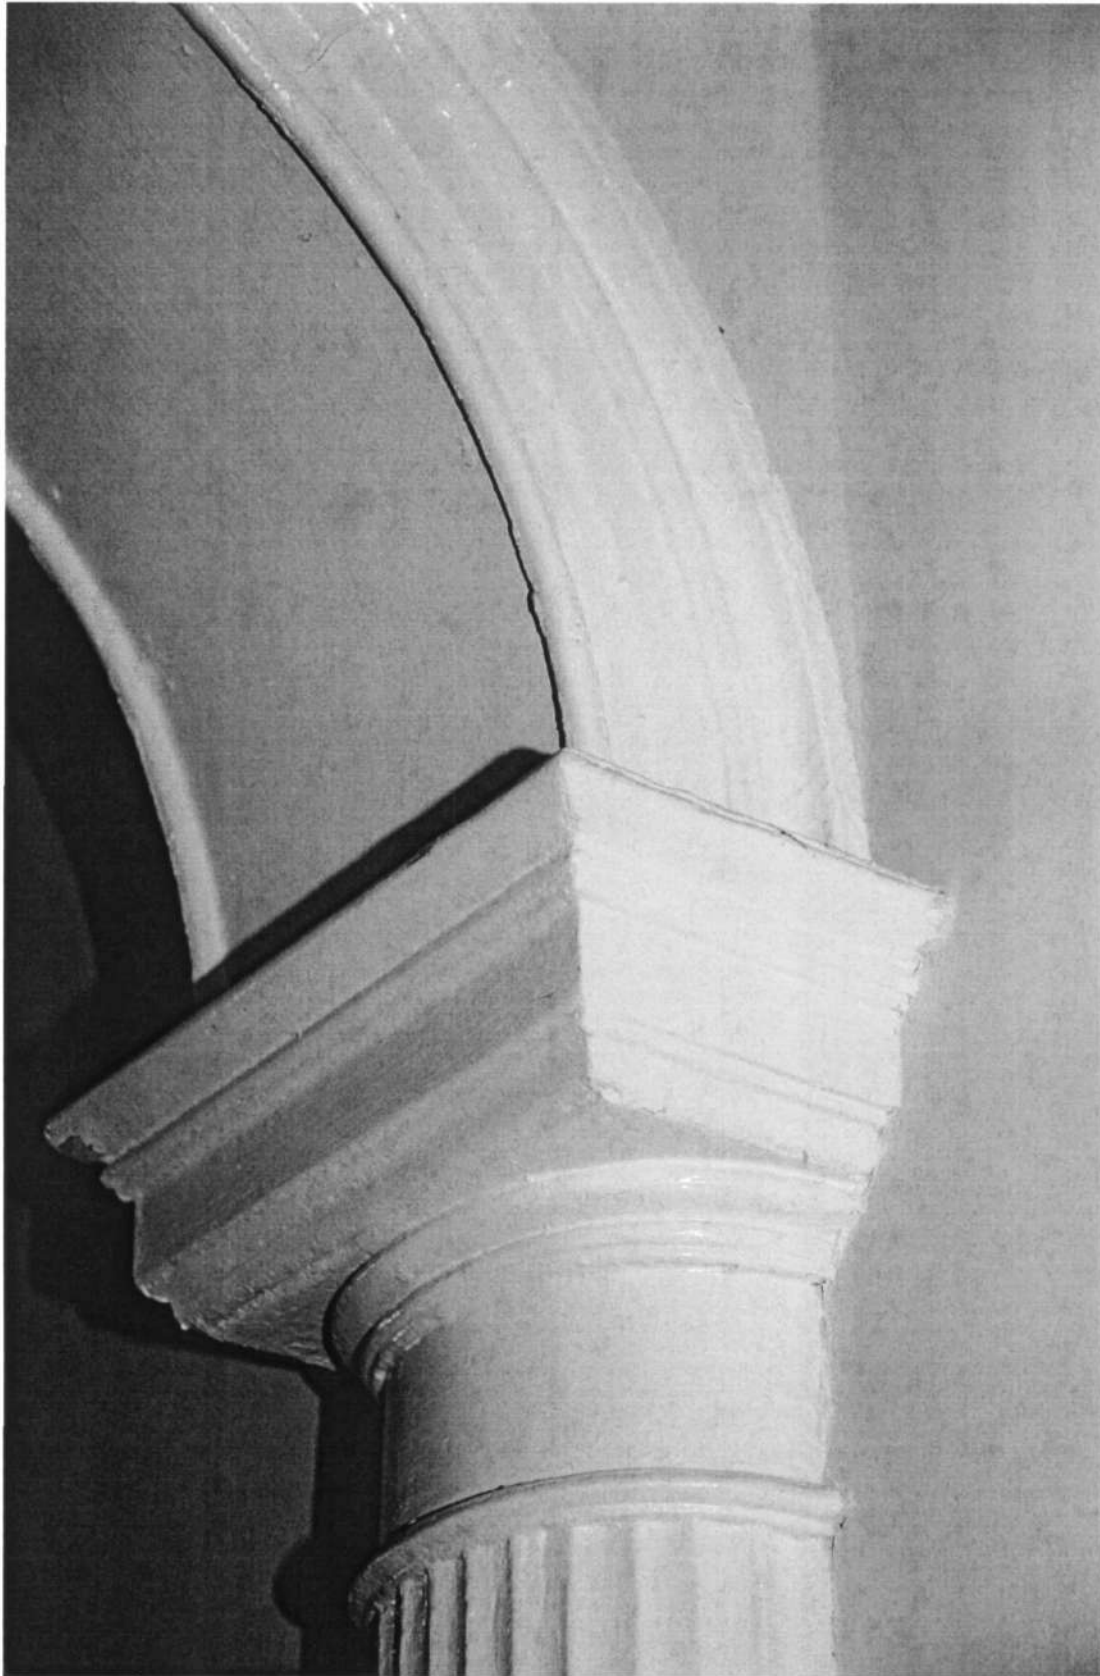
HO- 49 Mount Hebron, Calvin Circle & Furrow Avenue Mansion House, passage arch column
Ken Short, April 2006, 5/30

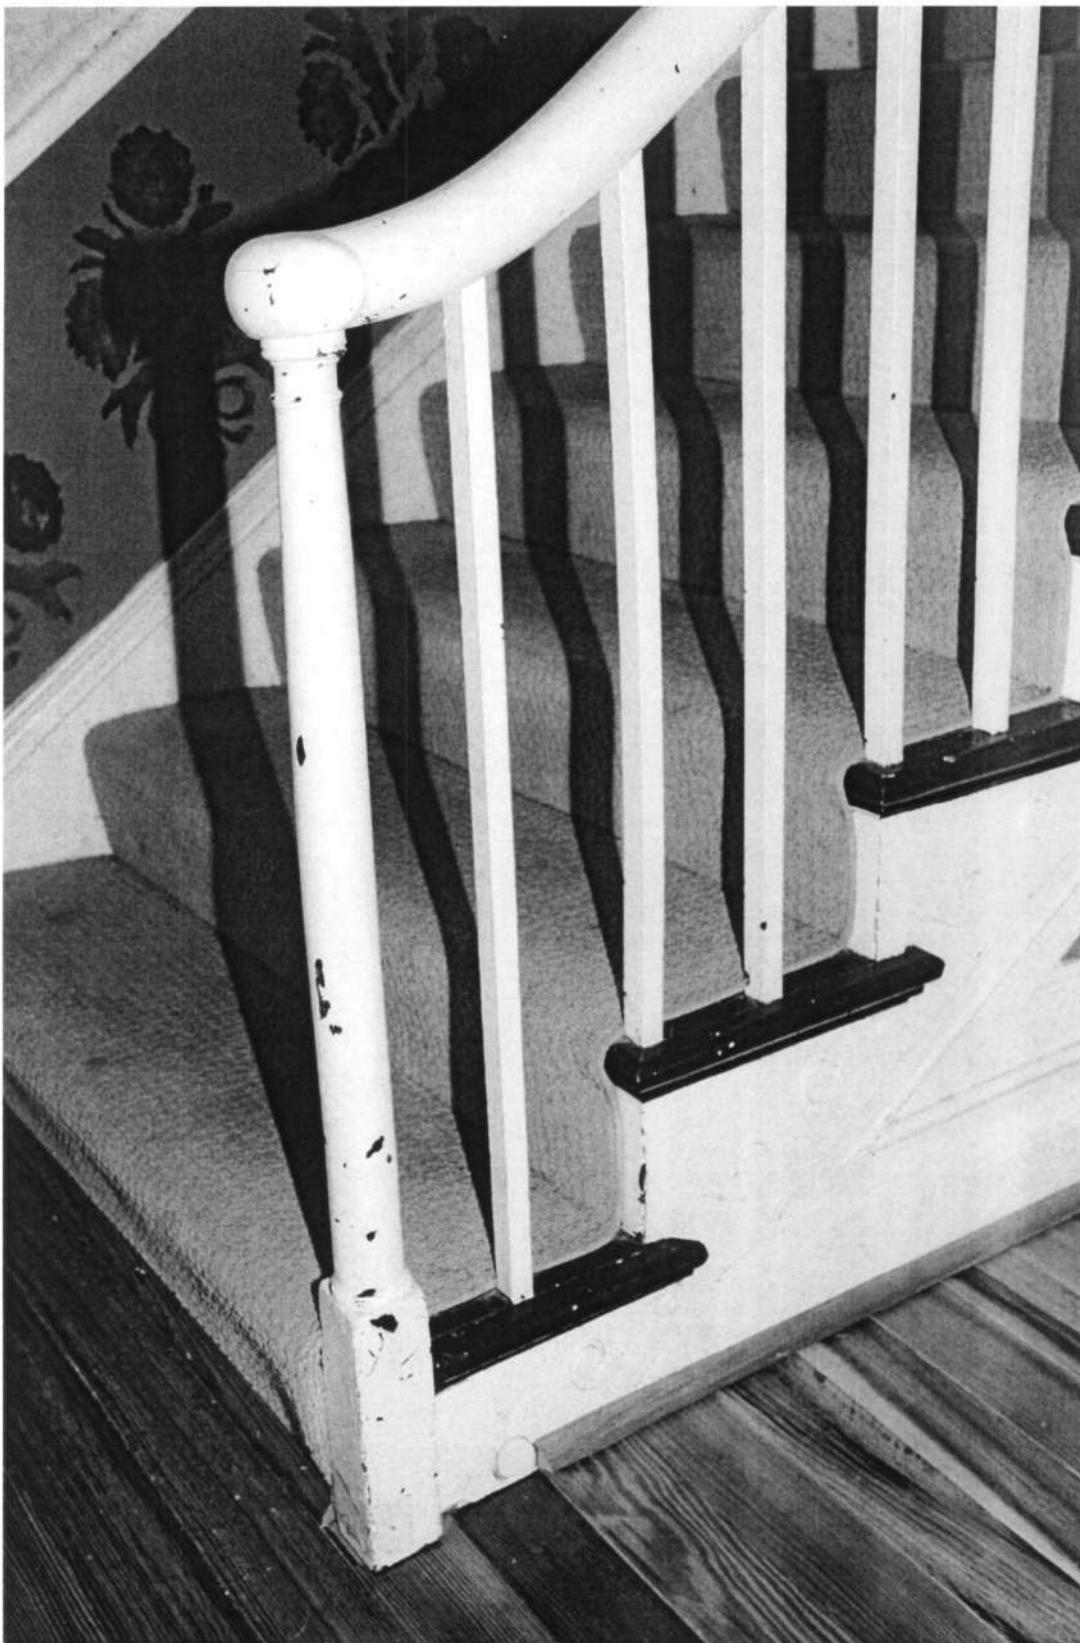
HO- 49 Mount Hebron, Calvin Circle & Furrow Avenue Mansion House, passage stair detail
Ken Short, April 2006, 6/30

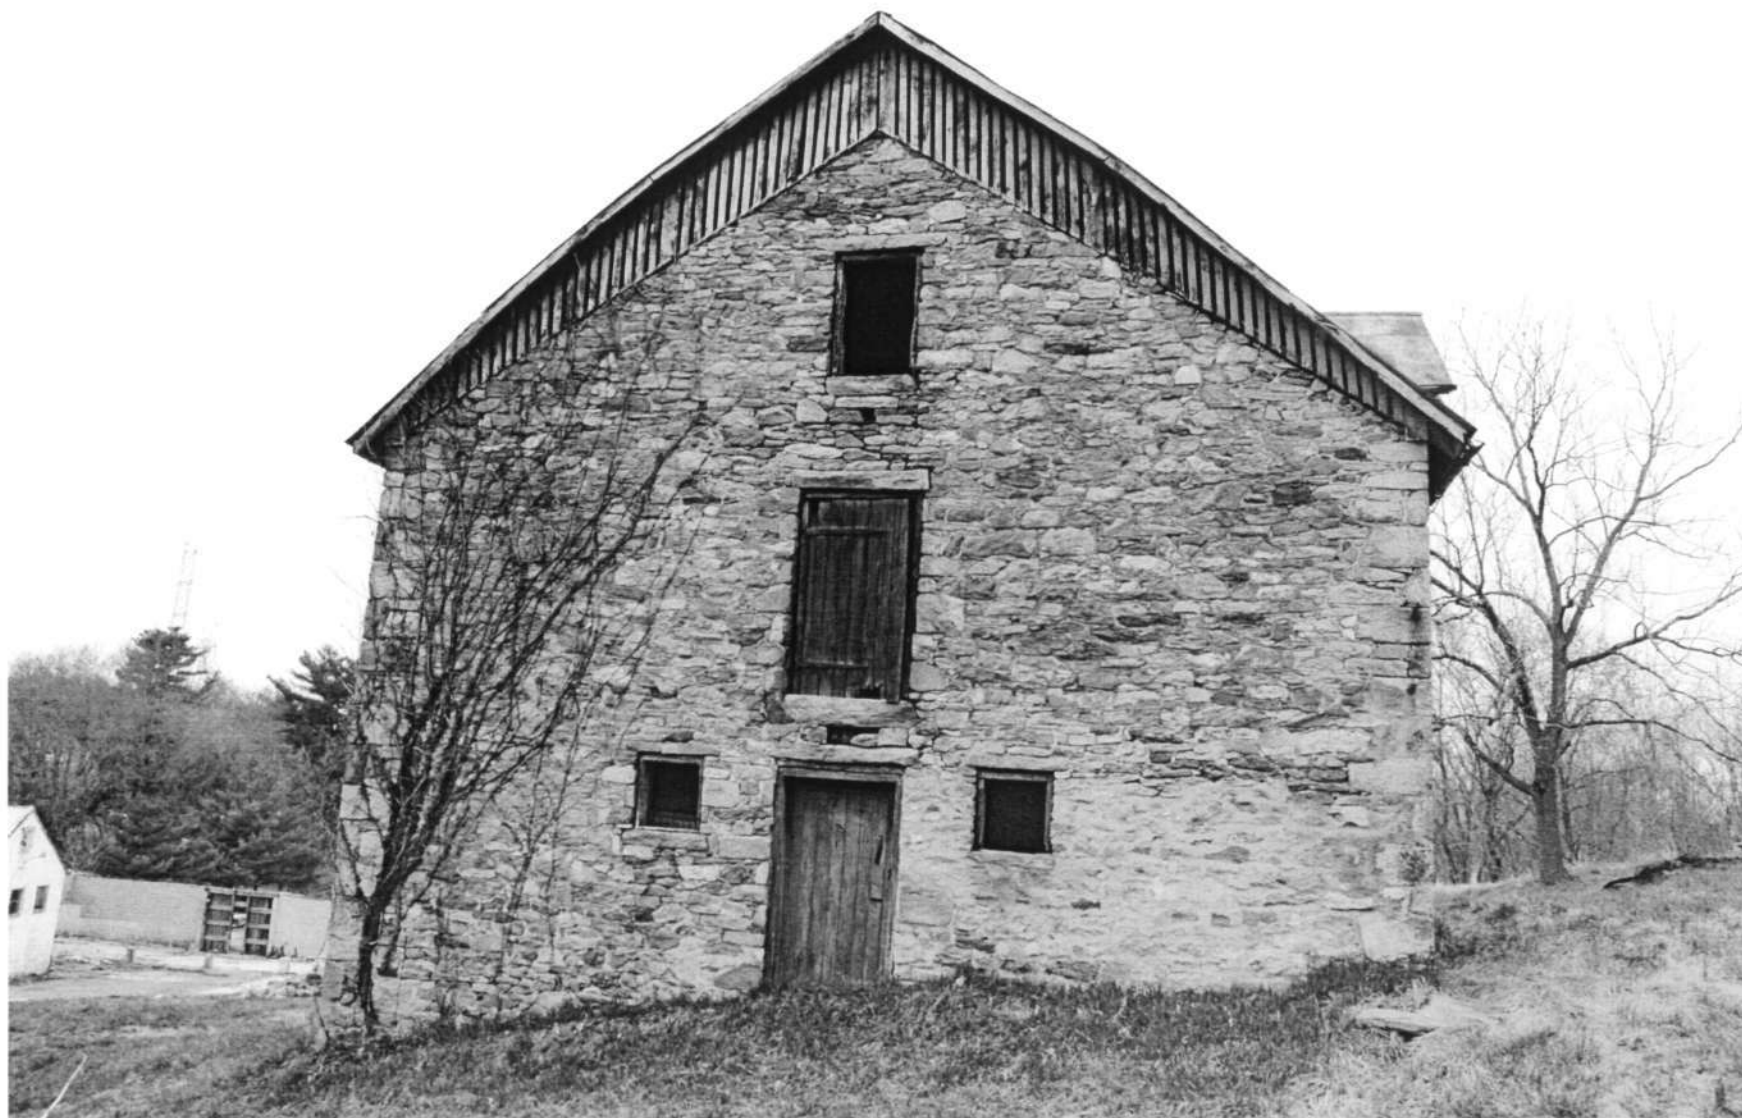
HO- 49 Mount Hebron, Calvin Circle & Furrow Avenue Stone Barn/Slave Quarter, southeast elevation
Ken Short, April 2006, 17/30

The slave quarter (ca. 2nd quarter 19th c.), a multi-purpose 2 1/2-story stone building in fair to good condition, is set on the west side of the farm lane between the bank barn and the manor house. The gable-roofed stone building has a corrugated metal roof. Wood louvers infill window openings and door openings hold wood doors. Window and door openings have stone sills and lintels. While structurally sound, the building has been empty for decades and is suffering from deferred maintenance.
